Receiver AGC During OTM 339

Static Phase Error During OTM 339

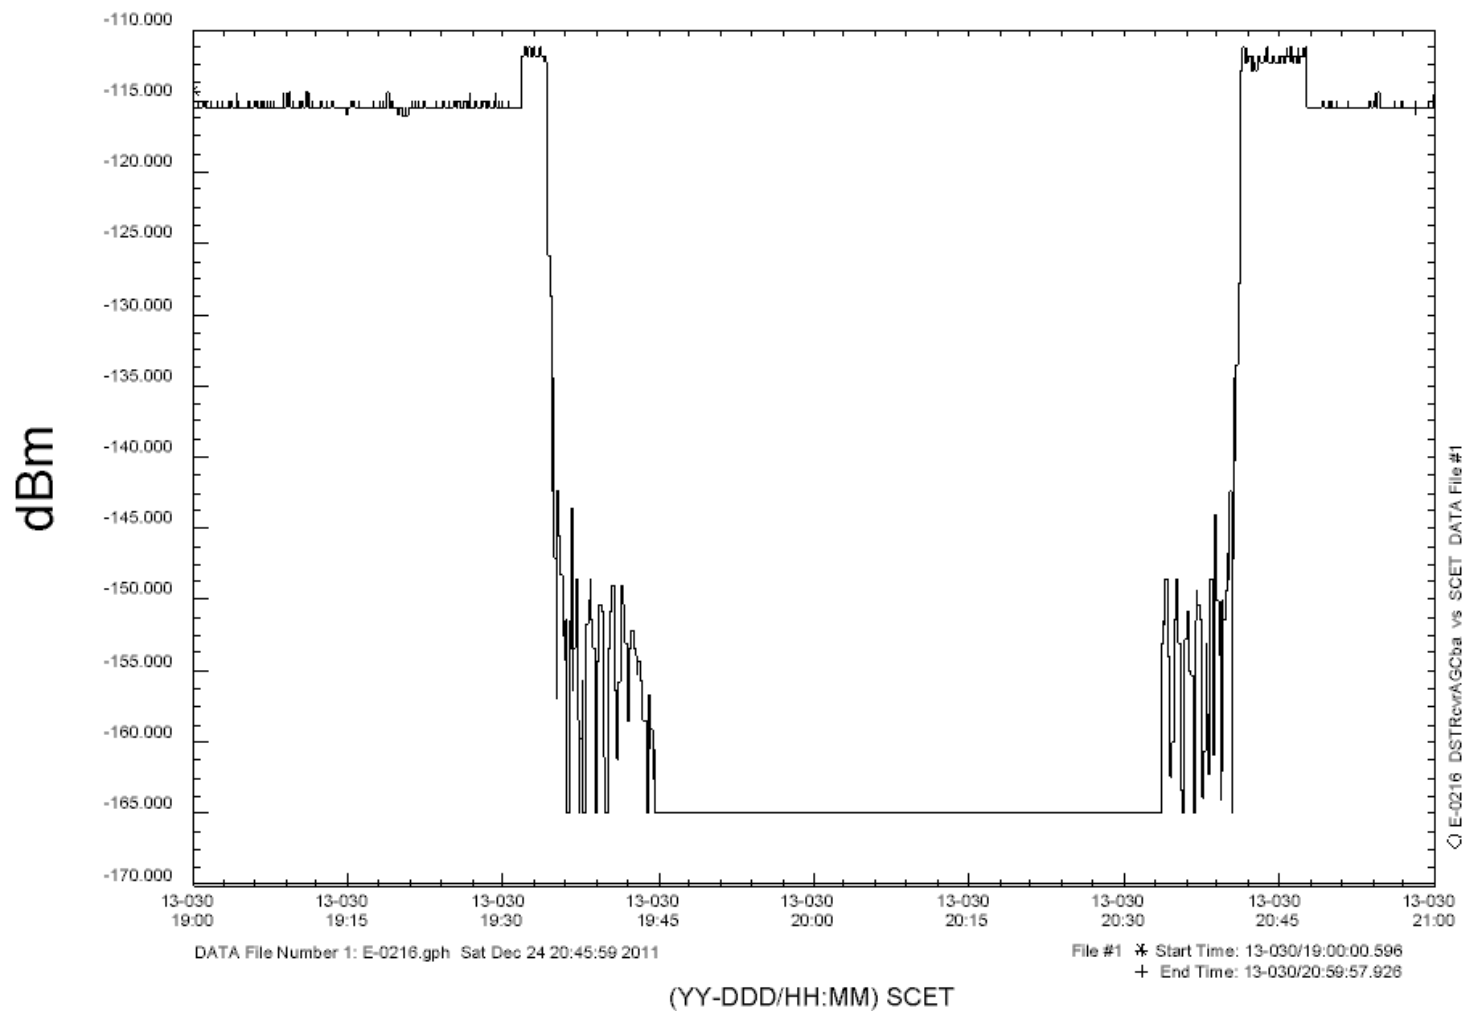
E-0216 (DSTRcvrAGCba) vs SCET

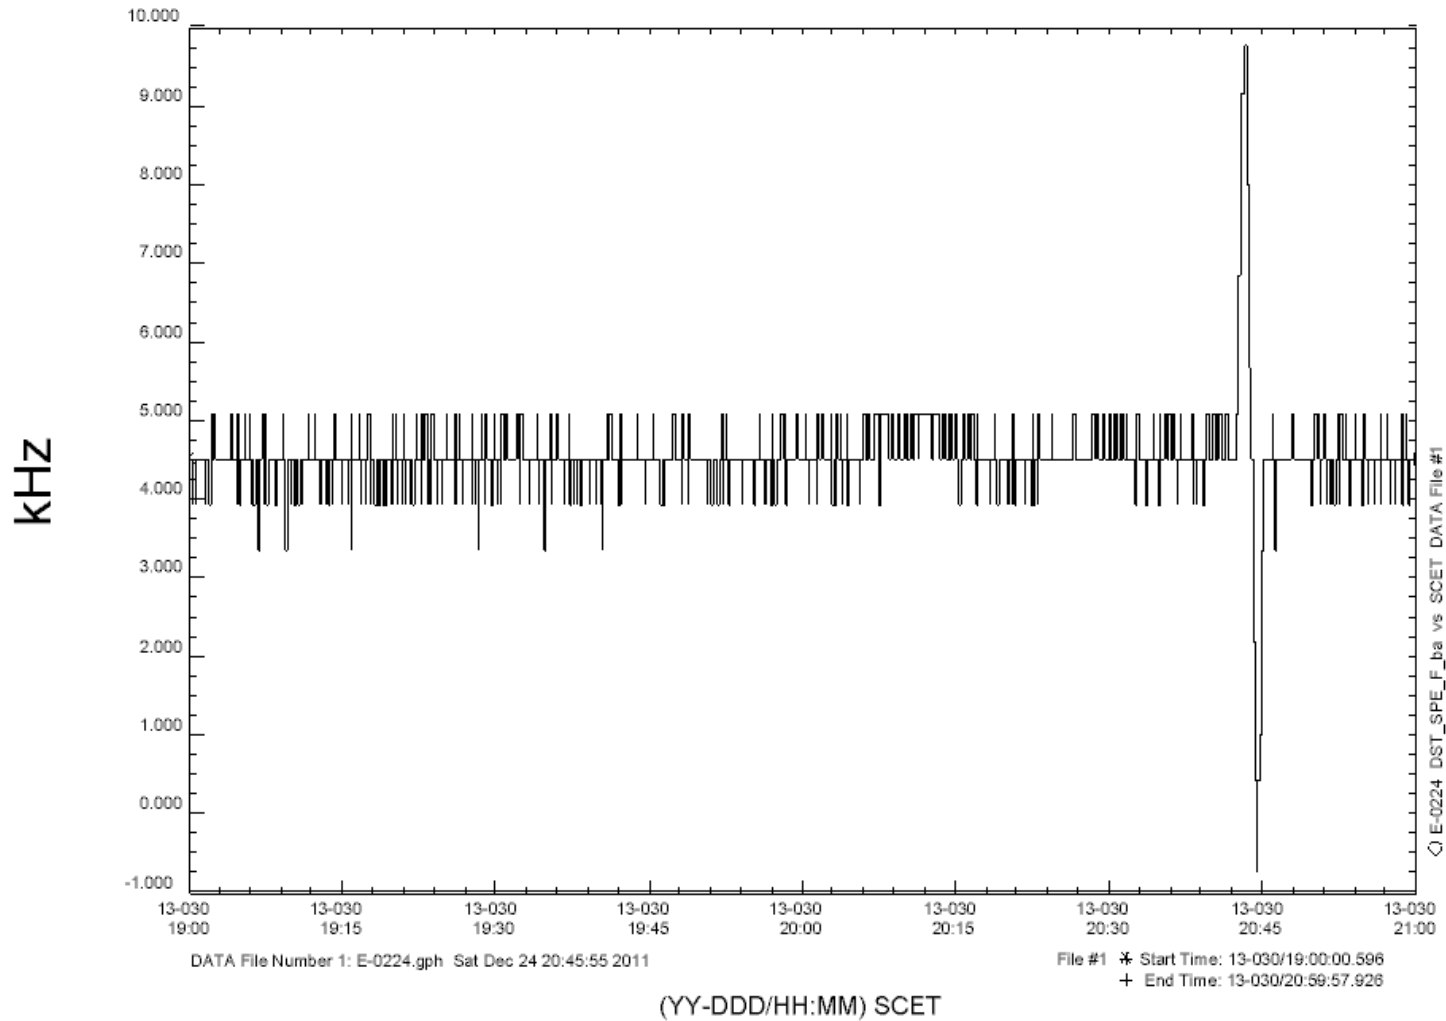
E-0224 (DST_SPE_F_ba) vs SCET

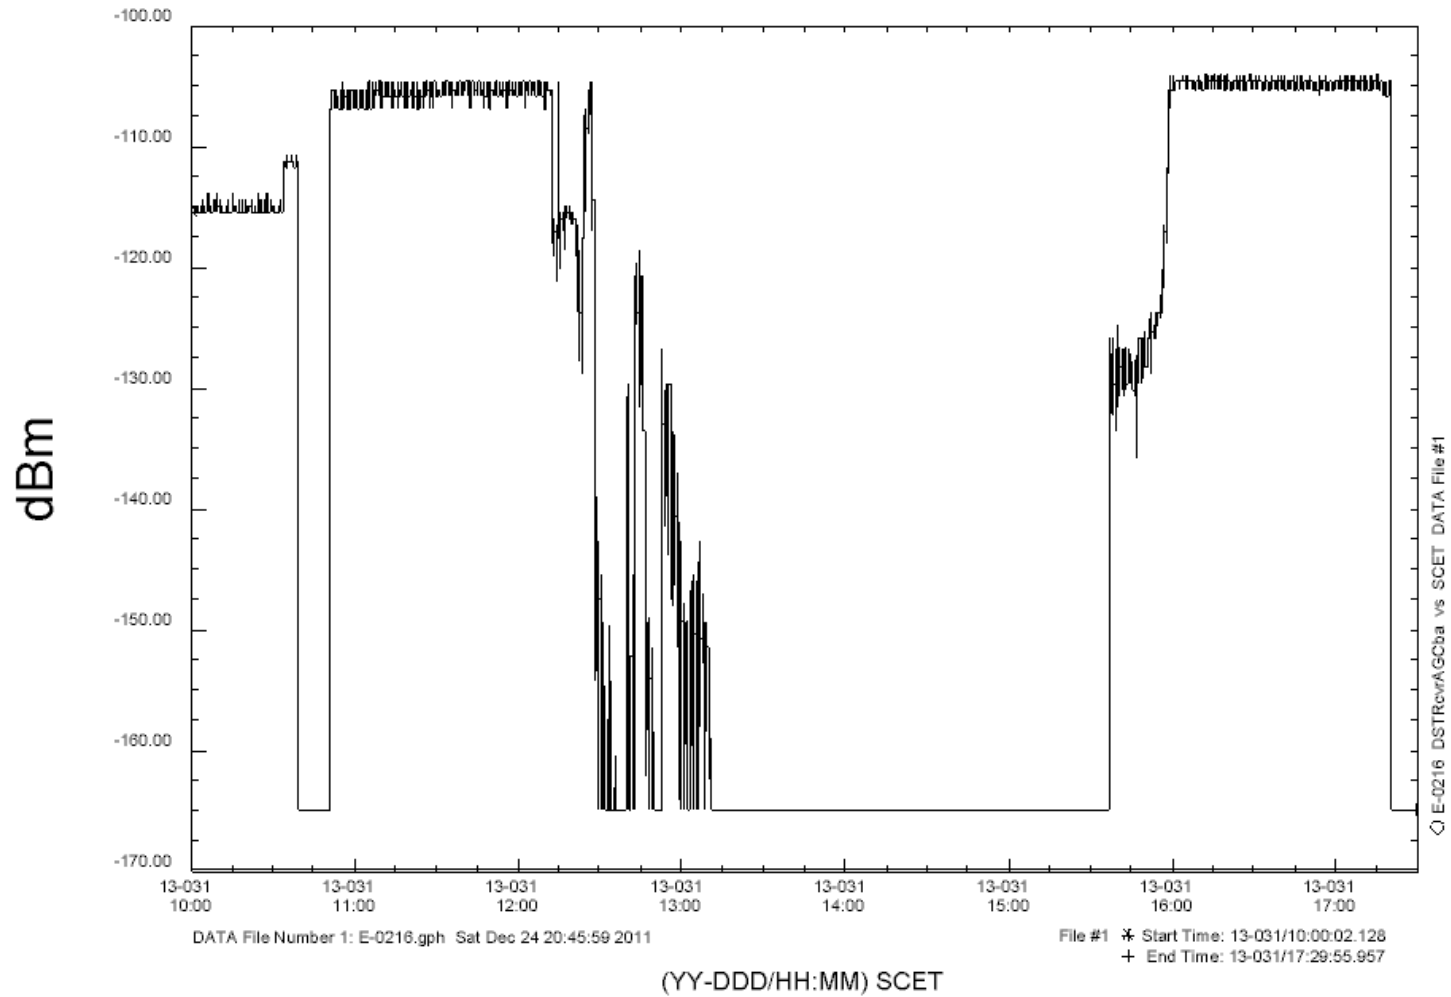
Receiver AGC During The Occultation

E-0216 (DSTRcvrAGCba) vs SCET

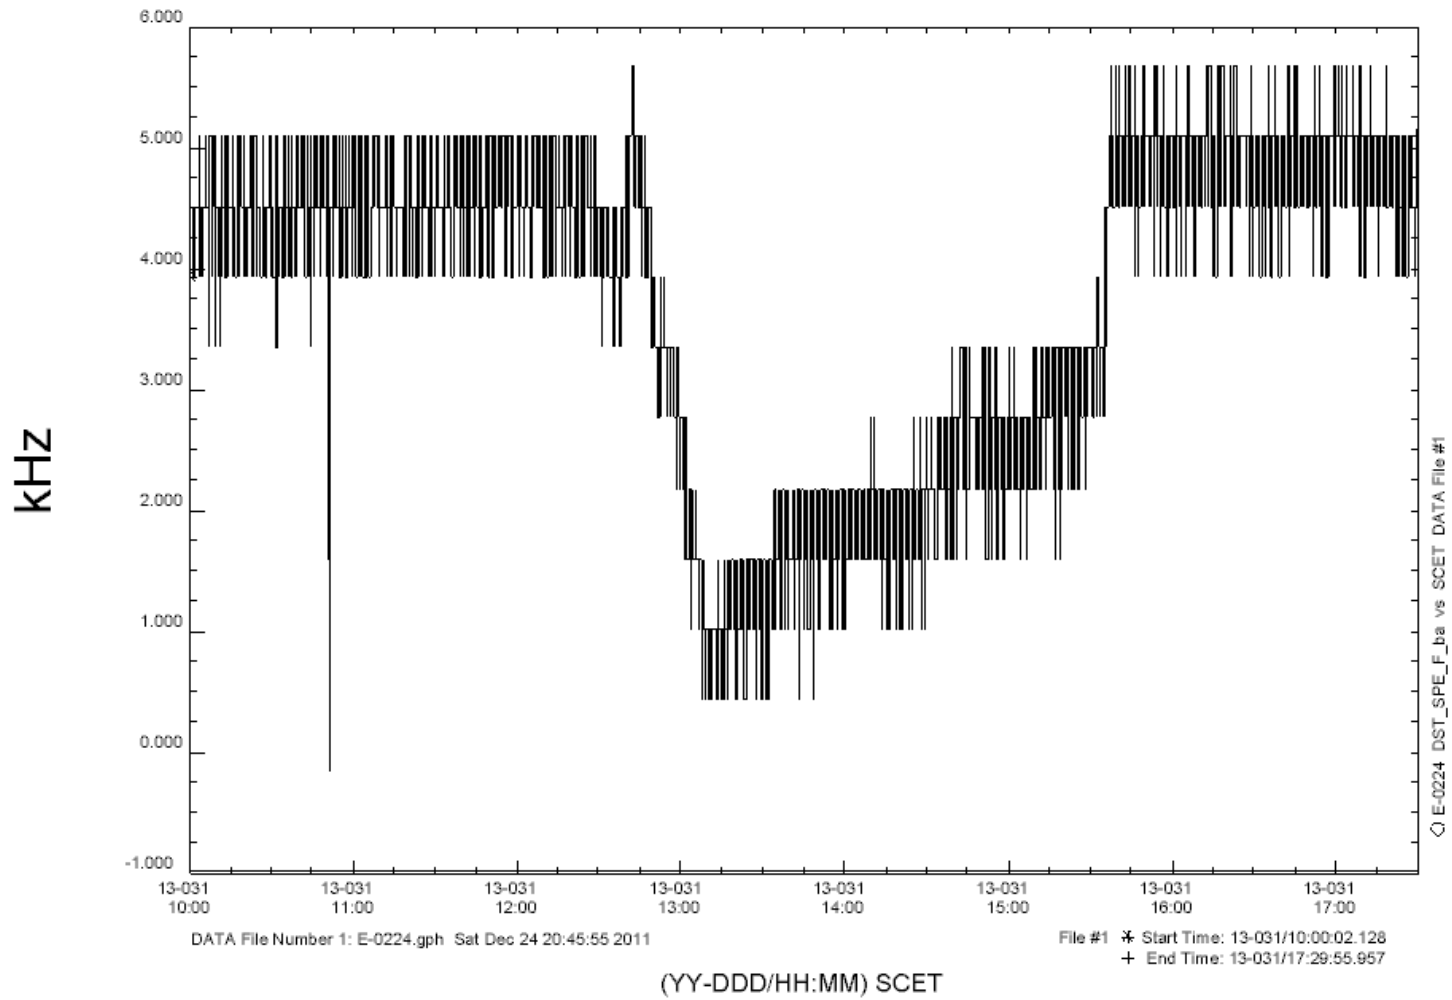
Static Phase Error During The Occultation

E-0224 (DST_SPE_F_ba) vs SCET

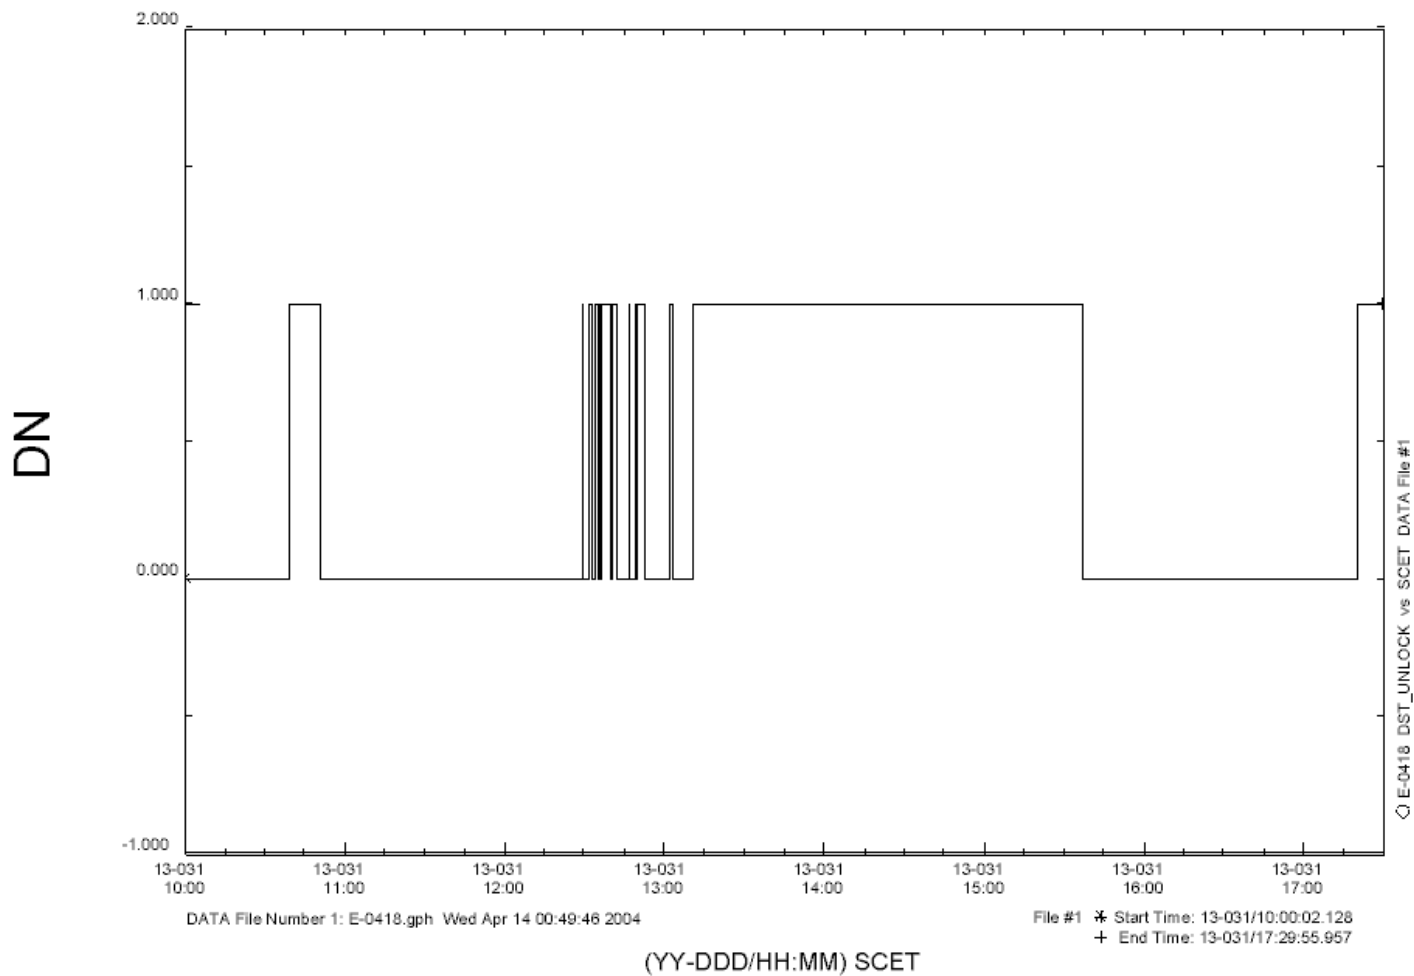
DST Lock Status During The Occultation

E-0418 (DST_UNLOCK) vs SCET

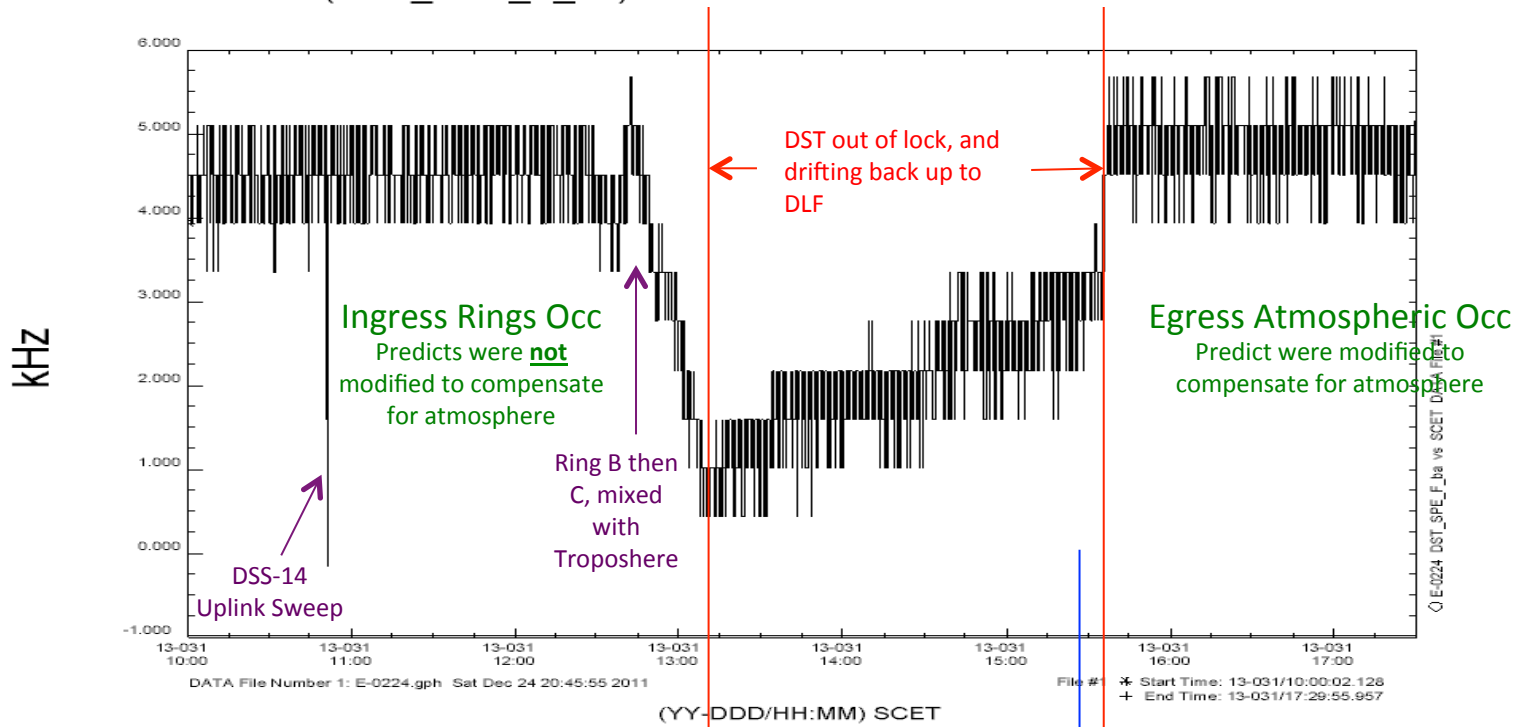
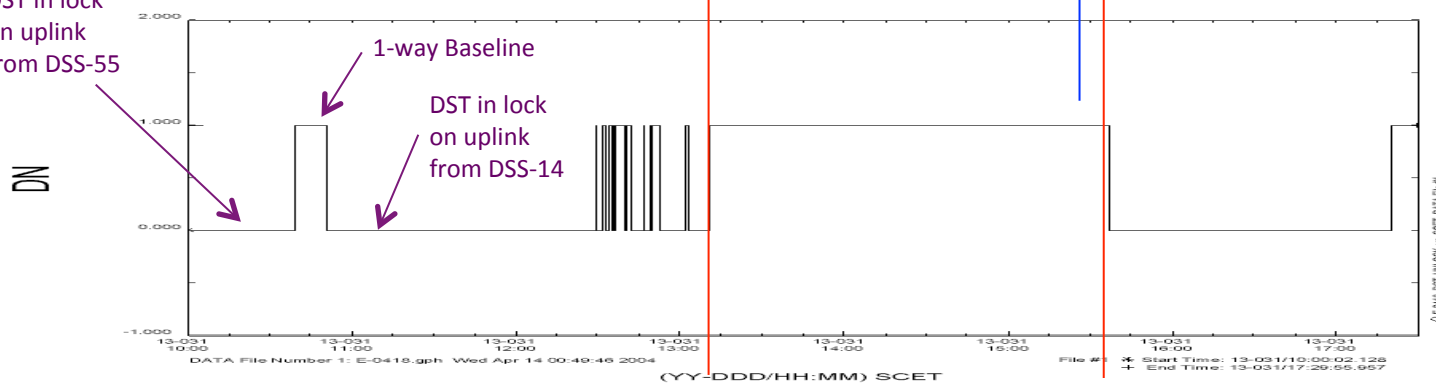
Rev 180 DST SPE & Lock Status During The Occultation

E-0224 (DST_SPE_F_ba) vs SCET

First Egress Signal
Observed (1-way)

DST in lock
Coherent signals observed
(2-way and 3-way)

E-0418 (DST_UNLOCK) vs SCET

0 = DST in lock
1 = DST out of lock

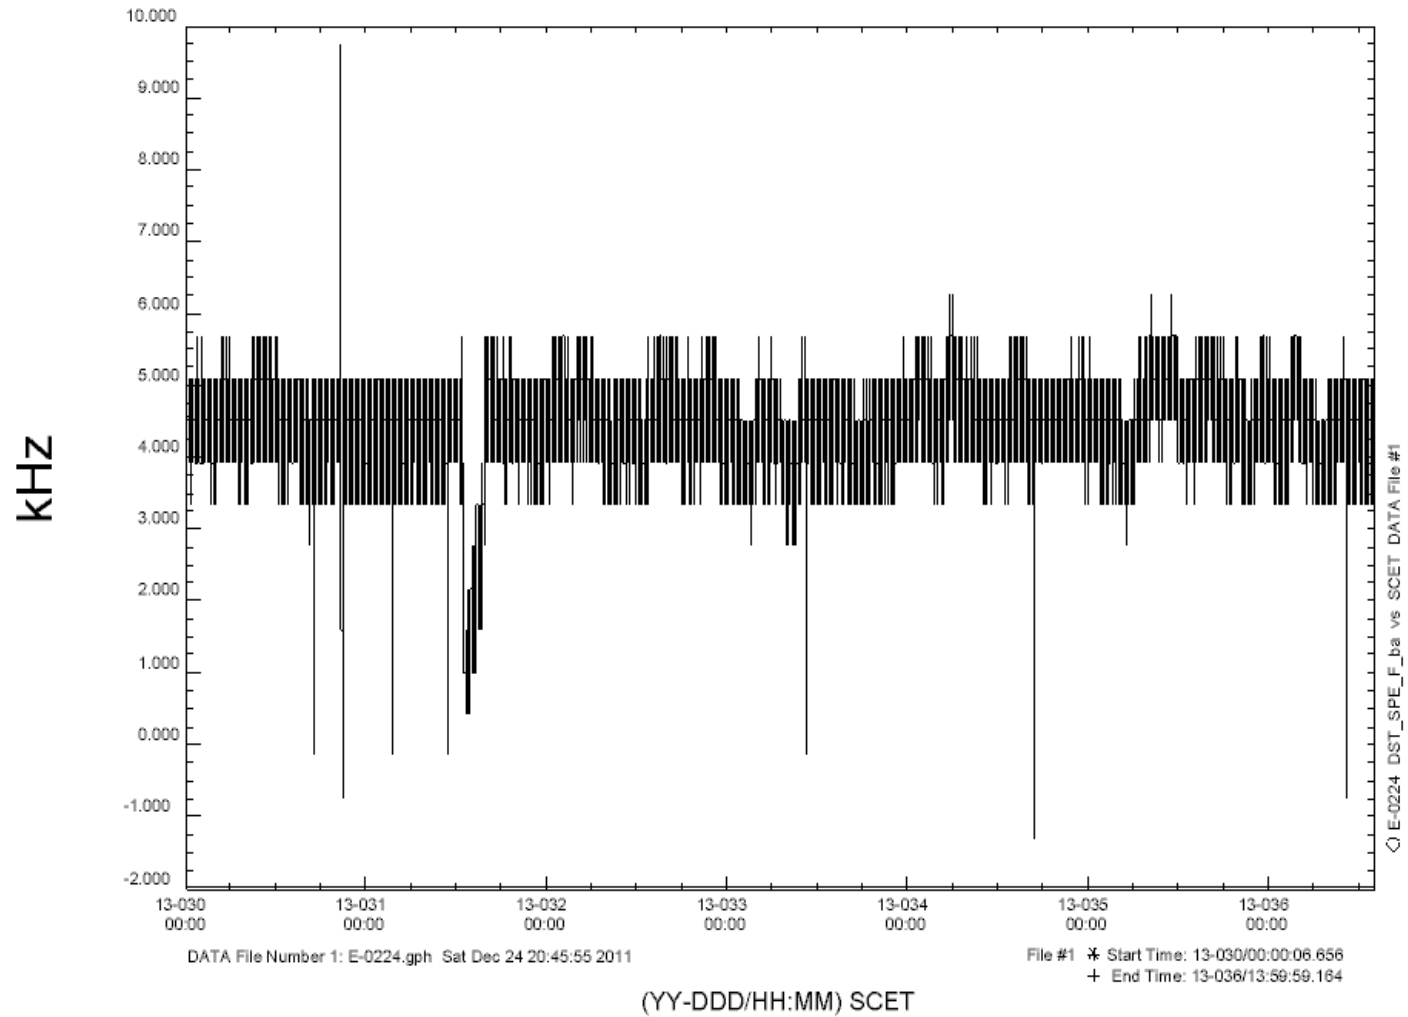
Static Phase Error Jan 30 to Feb 5

E-0224 (DST_SPE_F_ba) vs SCET
